SUBJECT: City Park Lake Dam (Mo. 30588)

CITY PARK LAKE DAM
CRAWFORD COUNTY, MISSOURI

MISSOURI INVENTORY NO. 30588

PHASE I INSPECTION REPORT
NATIONAL DAM SAFETY PROGRAM

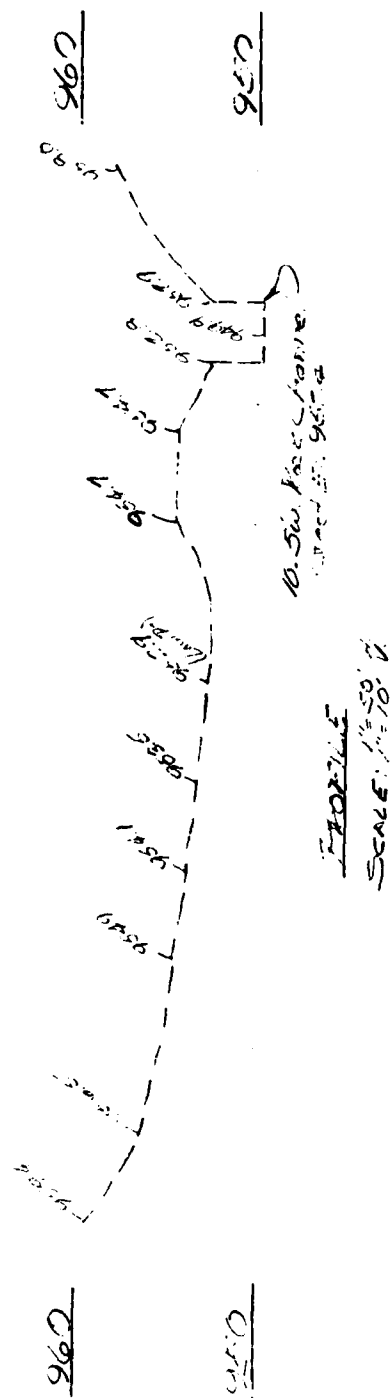
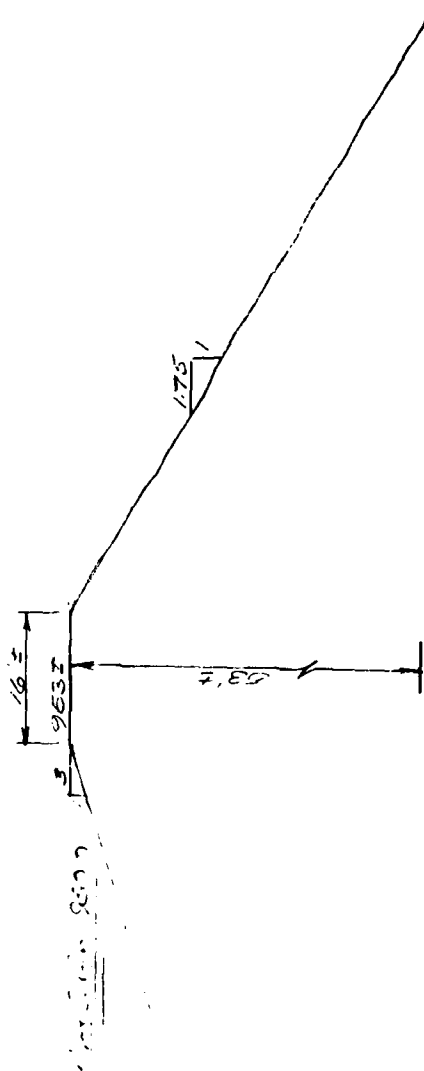
CITY PARK LAKE
DAM PROFILE and
CROSS SECTION
